# Cal Poly Pier Water Quality Monitoring System

## Final Report

January 24, 2006

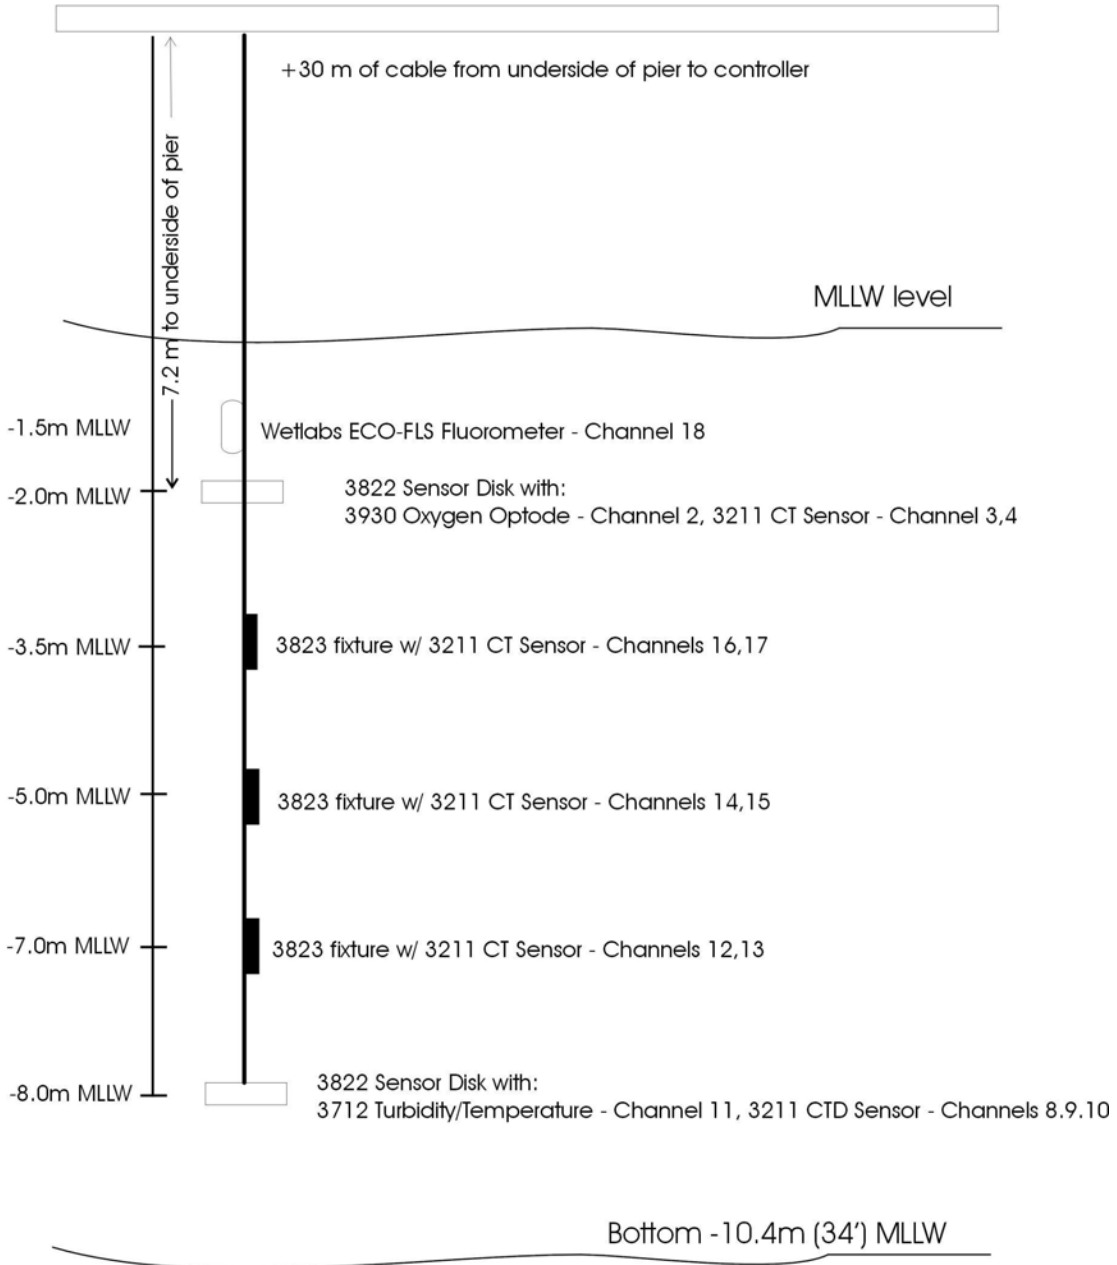
**Figure 1.** Cal Poly Pier Hydrostation sensor array.

The hydrostation instrument array, in its current configuration, is shown in **Figure 1**. Located at its uppermost elevation (-1.5m MLLW), is a Wetlabs ECO-FLS Fluorometer. This instrument measures fluorescence as an indicator of phytoplankton density in the upper water column. It is the only fluorometer in the array and was placed where light levels and the density of photosynthetic plankton within the water column were anticipated to consistently be at their highest. The presence of some toxic phytoplankton (i.e., *Pseudo-nitzschia* spp., *Gonyaulax* spp.) have been documented in the San Luis Bay area by local and federal programs (Mussel Watch). However, the frequency and magnitude of toxic blooms in this region is unknown. Recent studies have shown direct correlations between toxic phytoplankton abundance, fish kills and degraded water quality. Because toxic phytoplankton abundance in the water column fluctuates over relatively short time scales (3-4 days) in response to nutrient fluxes from San Luis Creek, randomized shore based sampling techniques are not sufficient for monitoring water quality. Monitoring of water column fluorometry provides a real-time indication of water quality, and contributes to maintaining the safety of the public that utilize San Luis Obispo Bay.

Positioned at five different depths (-2.0m, -3.5m, -5.0m, -7.0m, and -8.0m MLLW) below the fluorometer, are conductivity/temperature (CT) sensors. As indicated by their name, the CT sensors measure conductivity (used to calculate salinity) and temperature at each depth, which provides an indication of the influence of runoff and off cold water oceanic upwelling. The lowest CT sensor was replaced in 2004 with a CTD sensor that also measures depth (pressure). This provides information on both tide and wave height, which can be directly validated by the NOAA tide gauge station.

In addition to the CT sensor, an oxygen optode is installed at the -2.0m MLLW level. This sensor measures dissolved oxygen using an optical fluorescence technique. Fluctuations in the concentration of dissolved oxygen can be related to changes in biological oxygen demand (BOD), primary productivity, and the presence of some pollutants.

A turbidity sensor is located at the -8.0m MLLW depth. Turbidity is a measure of the cloudiness of a liquid. Increased turbidity can be due to run off from nearby San Luis Creek, turbulence due to wave action, or blooms of microscopic plants or organisms.

# Instrument diagram with wiring and channel assignments.

There is ~2 m of extra flylead cable if you need to cut the end and resplice new connectors for the controller.

Underside of pier +7.2 m(23.6') MLLW

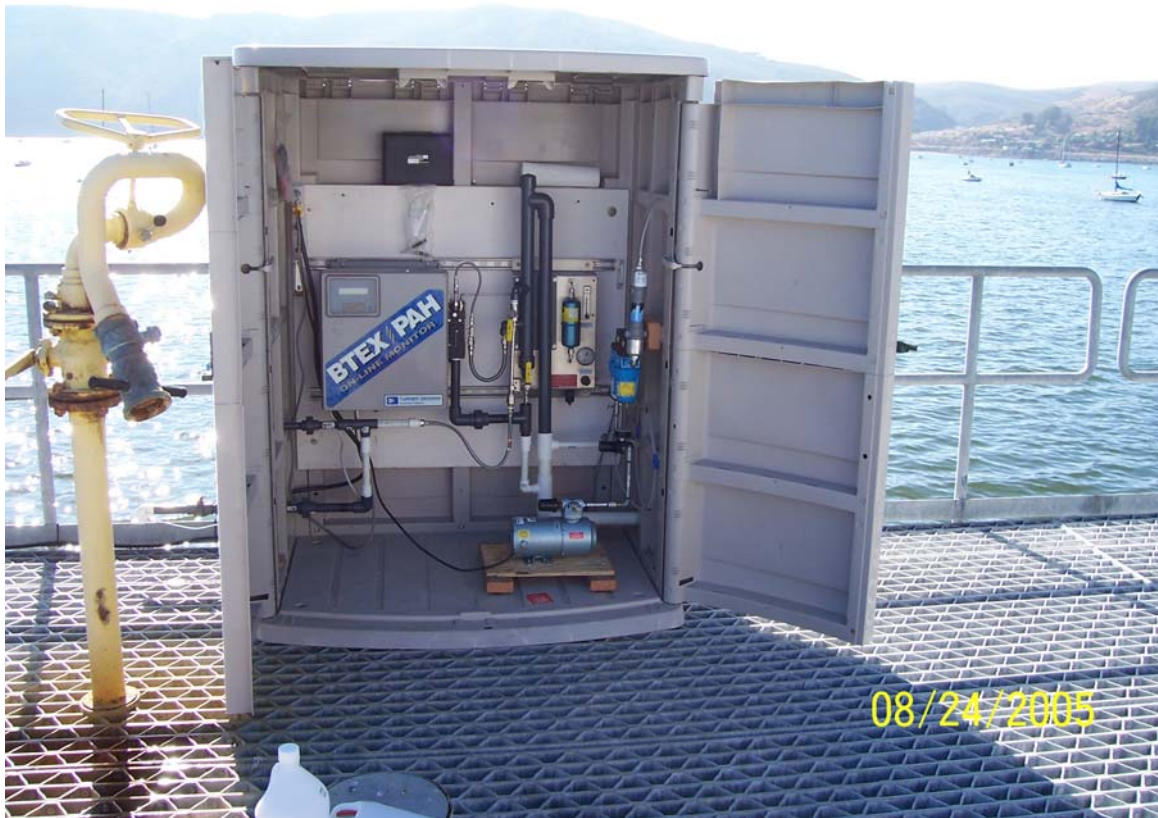
**Figure 2.** Cal Poly Pier Hydrostation, hydrocarbon monitor.

The Turner Designs TD-4100 hydrocarbon monitor (**Figure 2**) is installed separately from the previously described hydrostation sensor array. The monitor is a flow-through device that measures the concentrations of aromatic hydrocarbons (including gasoline, oil, and diesel fuel) in the seawater flowstream optically. The hydrocarbon monitor is located on the deck of Cal Poly Pier near the hydrostation sensor array. Water is drawn into the monitor via a pump located at this same elevation. After passing through the monitor the water is discharged back into the ocean. Since the levels of hydrocarbons are measured optically, no chemical reagents are introduced into the discharge flow.

The Turner Designs TD-4100 hydrocarbon monitor (**Figure 2**) installation was completed during the summer of 2005 and went into operation on August 24, 2005. Turner Designs sent a representative to the site to train Tenera and Cal Poly staff on operation and calibration. After three months of operation, the seawater intake piping was severely damaged during the storms of December 2005. The system is currently being repaired and redesigned by Tenera and Cal Poly (beyond the performance period of this grant) and is anticipated to be back in operation in February or March of 2006.

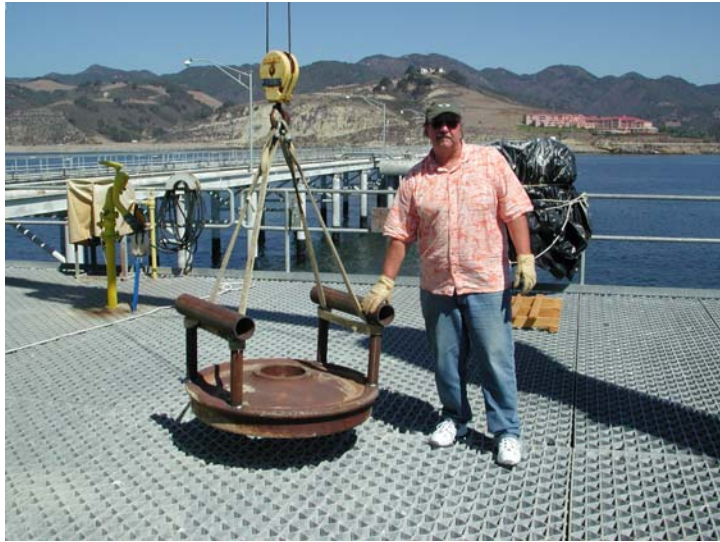
**Figure 3.** Railroad wheel used to anchor the sensor array.

The hydrostation sensor array was deployed on September 22, 2003. The array is situated beneath the pier, just inboard of one of the pilings. This location shields the array from potential encounters with boats or debris that could damage the sensors or data cable. The array is anchored using an 815-pound railroad wheel (**Figure 3**).

After the deployment of the instrument array (**Figure 5**) in September, there was a storm event during the first winter. It was discovered that the movement of sand beneath the pier was sufficient to leave the railroad wheel suspended from the array above the bottom. To avoid a repeat of this situation, the winch is periodically backed-off and then retensioned to assure that the wheel remains in contact with the bottom.

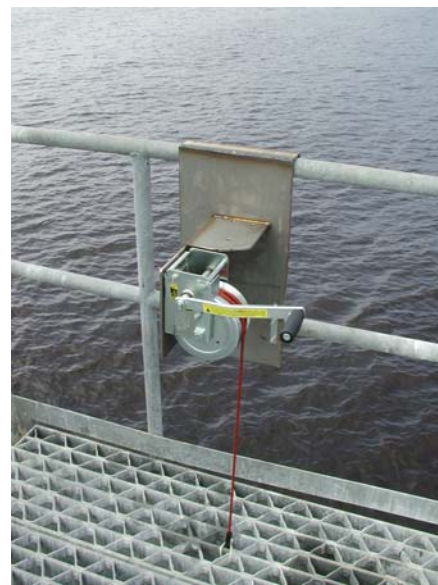
**Figure 4.** Sensor array tensioning winch.

slackening the cable, the array can be lifted onto the pier deck for cleaning, maintenance, or repairs. When the cable is tightened using the winch, the array is secured in its appropriate position by the weight of the wheel.

The upper end of the array is secured to a horizontal I-beam that supports the upper deck of the pier. The lower end of the array is attached to a cable that is fed through the cross bars welded to the wheel and secured to a winch affixed to the steel railing that encloses the pier deck (**Figure 4**).

In this fashion, the railroad wheel acts as a pulley at the end of a clothesline. If the winch is backed-off,

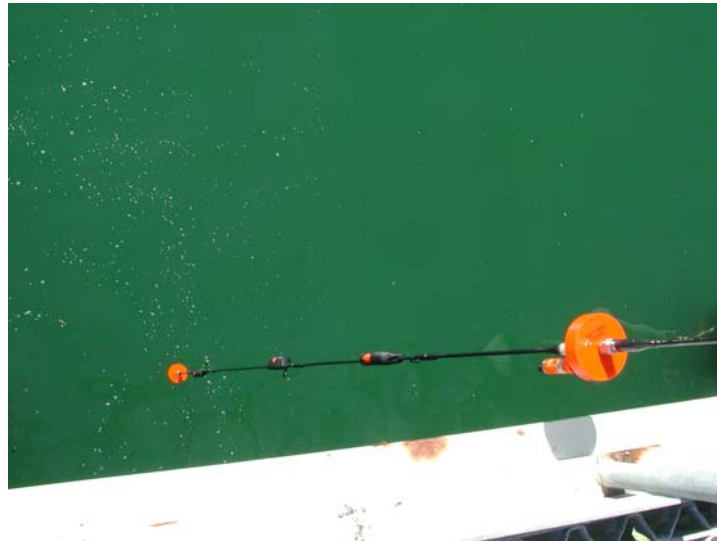
**Figure 5.** Instrument array suspended above water off the pier showing locations of sensors at five depths.

was first inspected by a pair of Tenera's divers, who assessed the condition of the cable, sensors, and railroad wheel anchor. The entire array was found to be fouled with a layer of hydroids and bryozoans that, at times, reached a thickness of about four inches.

Beneath this layer, much of the cable surface and the bodies of the individual sensors were encrusted with barnacles and tubeworms. The instrument cable showed no evidence of abrasion or other damage.

The railroad wheel was stable on the bottom, in its proper position, and in excellent condition. The chafing gear (3 inch ID reinforced PVC hose) that protects the tensioning cable from abrasion by the wheel was in good shape. The plastic coating on the tensioning cable showed some wear near the top deck of the pier, but the cable itself was undamaged. Following this inspection, the divers videotaped the entire submerged portion of the array. The divers then used 3M scrub pads and plastic brushes to perform a cursory cleaning of the cable and the sensor housings and mounts. All of the sensing surfaces were avoided during this portion of the cleaning operation. The array was then switched off at the scanner box in preparation for removal from the water.

When tension on the cable was removed, the array moved easily through the chafing gear on the railroad wheel. As the winch was backed-off, the array was lifted from the water and laid on the deck of the pier. All of the cable and sensor surfaces were thoroughly cleaned. The sensing surfaces were only touched with cotton swabs, wooden utensils or other soft instruments. While the hydroids and bryozoans were easily removed, removing the hard-shelled encrusting organisms from the sensing surfaces was a time consuming and delicate job. The fluorometer was the most severely fouled sensor on the array. The entire downward facing surface (which includes the sensing windows) was encrusted with acorn barnacles (*Megabalanus californicus*) up to about 3/8 inch in diameter. The copper wiper, which is supposed to cover the fluorometer sensing windows and keep them from fouling between readings, was clean, but was not positioned over the window and appeared as though it never had been. The instrument was carefully cleaned without using metal tools or abrasives (fingers, cotton swabs and wooden tools). After cleaning, the wiper was left in a position that did not obscure the windows. Electrical power was

not returned to the array until it was placed back in the water, so it is uncertain if the wiper was functional. After cleaning had been completed, the number two CT sensor (the level just below the upper sensor disk) was removed from the array so the integrity of its connectors could be checked. This sensor had been giving erroneous readings. The electrical connections were tight and dry. All metal surfaces were shiny with no evidence of corrosion. The connection was cleaned, as a precaution, and reassembled.

All of the array hardware was checked for wear and corrosion. Bolts, shackles, electrical connections, and fasteners were checked to assure that they were tightly secured. The array was then returned to the water and the winch used to take up the slack in the tensioning cable. Based on the observations made during the cleaning, Tenera recommended that the array be lifted to the pier deck, cleaned and inspected on a monthly basis.
